PROJECT  
STATE OF CALIFORNIA, DGS  
BOE ASSESSMENT

DESCRIPTION  
WATER DAMAGE  
SURVEY

LOCATION  
21ST FLOOR

SHT NO. SHT NAME  
21 A21

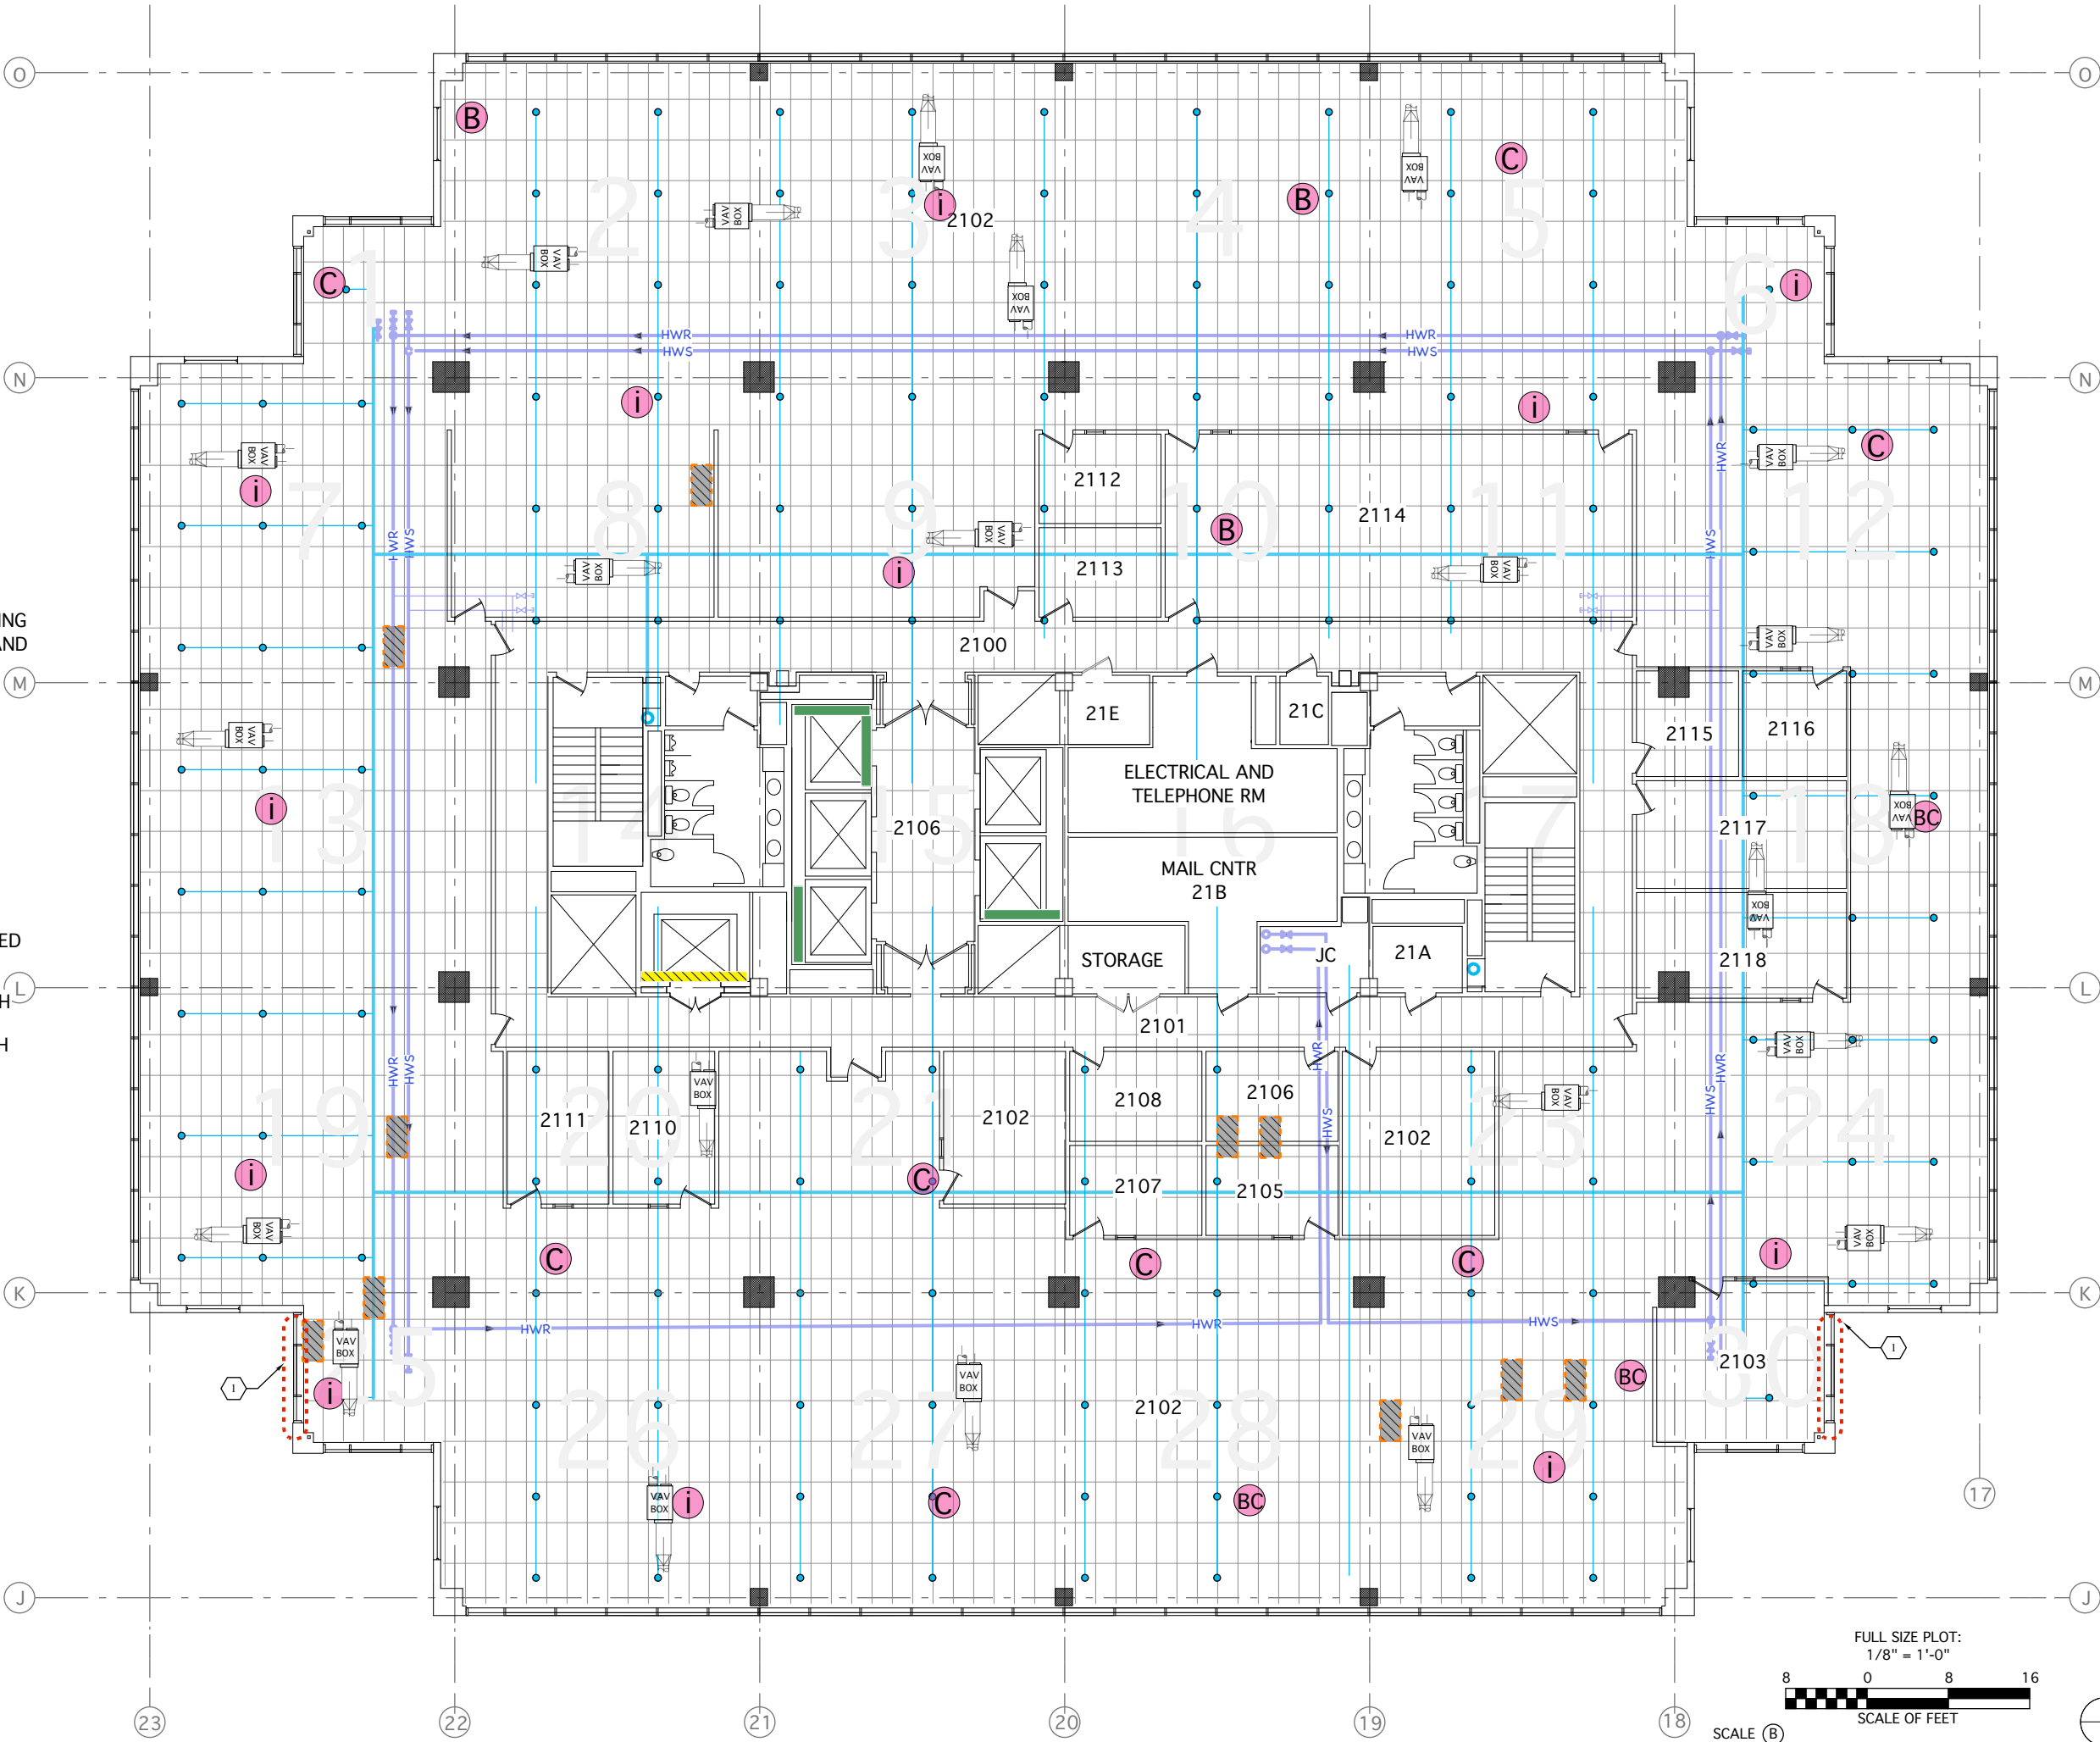
K/17.5 AND K/22.5  
DESTRUCT. TEST  
LOCATIONS HISTORIC
- 2

THE LOCATION OF VAV'S  
(TERMINAL UNITS) IS  
APPROXIMATE
